Manhole Inspection Summary

Manhole # S11KK1017MH

Insp Date: **5/29/07 11:16 AM**

Location Address: **4633 PARK HEIGHTS AVE** Cross Street: **WOODLAND AVE**

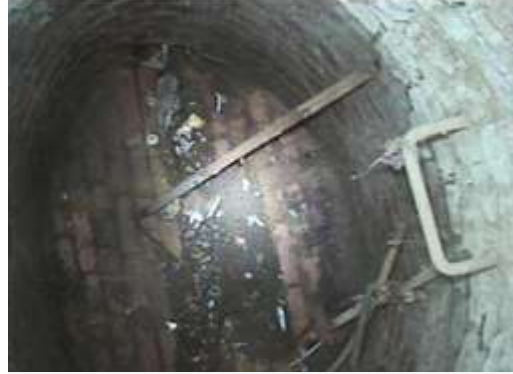
Top View

NOTE DEBRIS

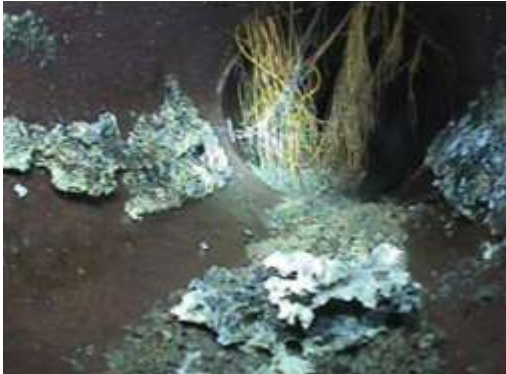
Defect 1

Condition: ☐ Sound ☐ Cracked ☒ **Root Intrusion** ☐ Deteriorated ☐ Leaks ☐ Debris

DEBRIS IN CHANNEL AND ROOT INTRUSION

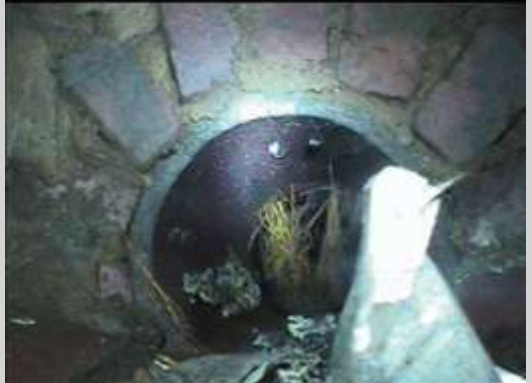
12 O'Clock Outflow

8 in. Circular Gravity Sewer
Pipe Out @ 12 O'Clock

Deposits: ☐ None ☐ Mud ☐ Sludge ☒ **Debris** ☐ Grease

Silt Depth: **1** (in.) Deposits Extent: **Medium**
